PARKER DAM

NDI No. PA 01126

PHASE I INSPECTION REPORT
~~NATIONAL DAM SAFETY PROGRAM~~

Parker Dam, Clearfield County, Pennsylvania
NDI No. PA 01126, PennDER No. 17-87
Laurel Run
Inspected 25 June 1980

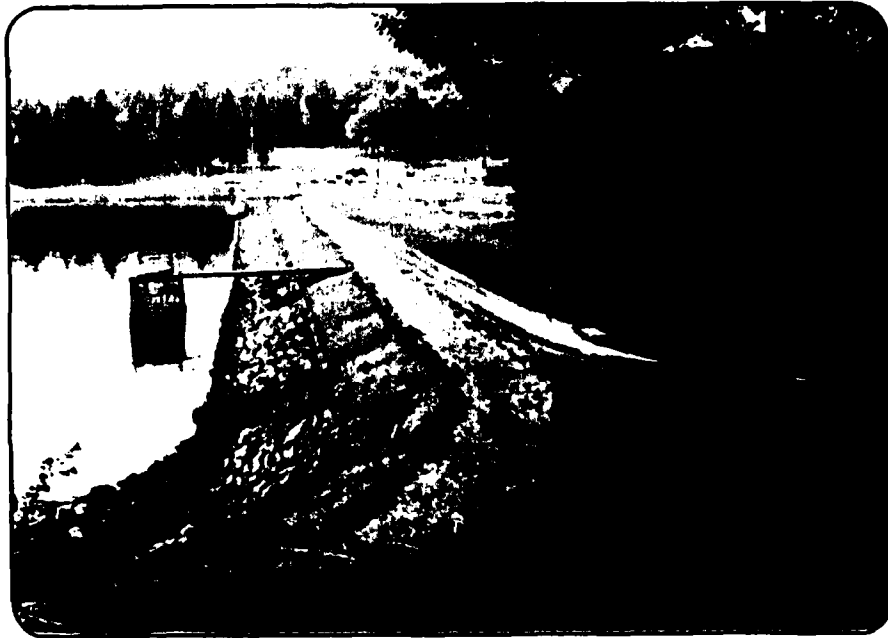
Overall View of Dam from Right Abutment

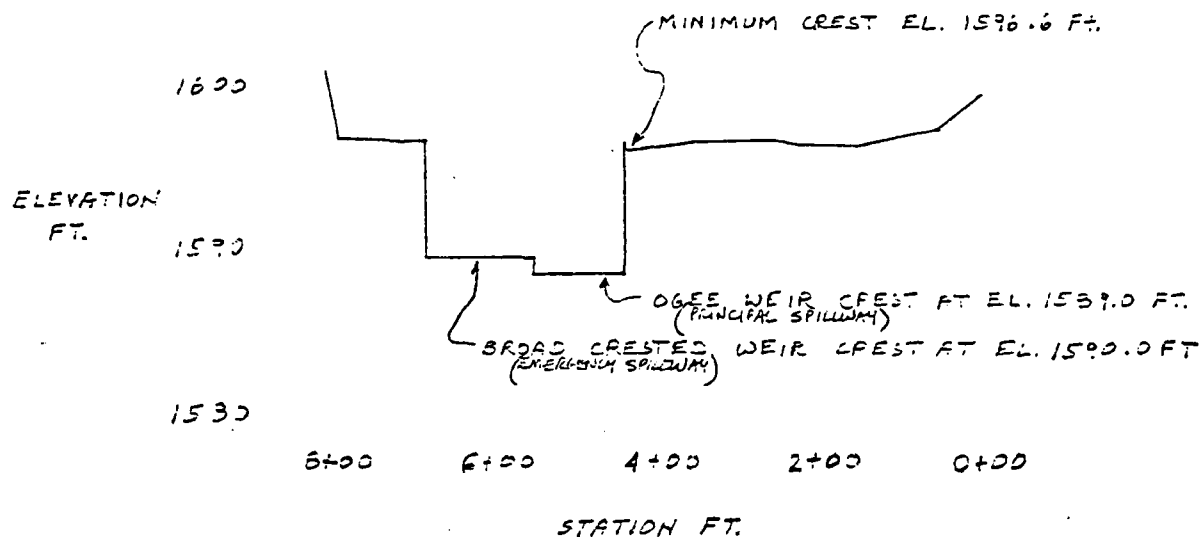
TOP OF DAM PROFILE

VISUAL EXAMINATION OF	OBSERVATIONS	REMARKS OR RECOMMENDATIONS
VERTICAL AND HORIZONTAL ALIGNMENT OF THE CREST	There is a low area on the crest and upstream slope of the dam adjacent to the right spillway training wall.	This area should be filled.

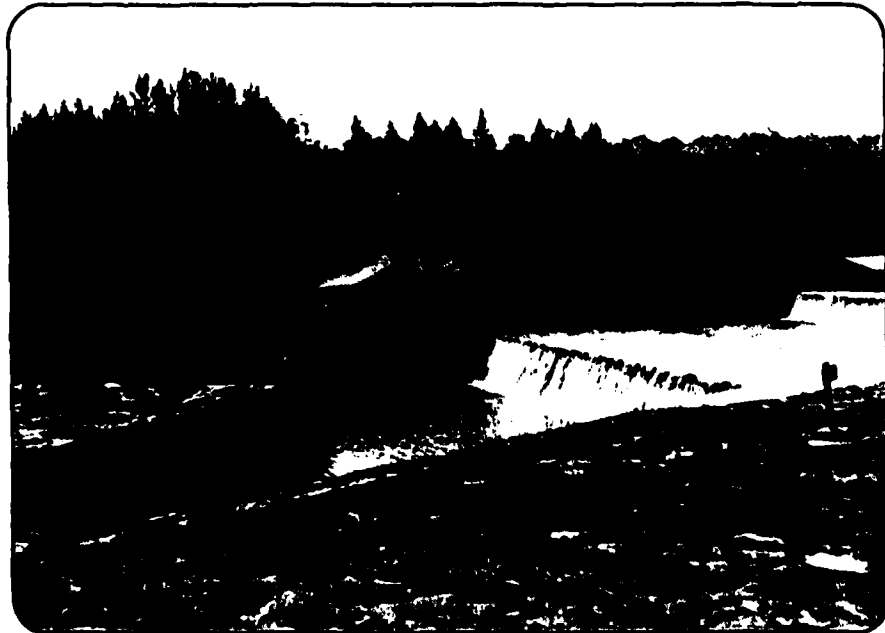
None were observed. The riprap on the up-
stream face of the dam and in the spill-
way discharge channel was in good condi-
tion.

PHOTO 2. View of Spillway Discharge Channel
